**Flood Control Project Maintenance
Levee Inspections**

Maintenance Issue Types Only, Levee Inspection Report By Mile - Fall 2018

Sutter Maintenance Yard Maintenance Area 0013

Waterway	Bank	Unit Miles	Inspection Start/End	Inspector
Unit No. 01 Cherokee Canal	Right	18.19	10/31/2018 10/31/2018	Bob Duffey

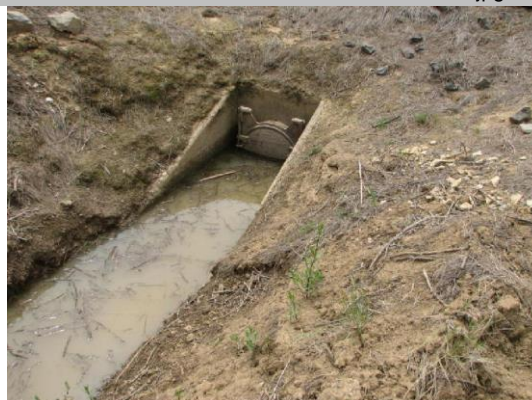
Photo 2 of 3 : UCIP_FA_2018_52189_66730.jpg

Comment Code					
Inspector Comment					
FS_ID:52189					
DS_ID:16350					
EP_NO: N/A					
Repair Type: No Action Needed					
Crossing Status: Found					
UCIP Comments: 6/14/2017 WS flapgate is buried by sediment- needs to be dug out. Pipe has been selected to be internally cleaned and inspected as part of the DMP project. (DWR Sutter Yard- A/Freitag)11/16/2016 Crossing appears to be in good condition. (DWR Sutter Yard- A/Freitag)4/28/2016 Crossing appears to be in good condition.7/14/2015 Crossing appears in good condition. No noticeable issues to report.5/21/2014 Same as last inspection.12/2/2013 Same as last inspection.7/15/2013 Same as last inspection.4/17/2012 WS headwall has been cleared of debris and sedimentation.					
FIELD_STRUCT_DESC: 24-inch corrugated metal drainage pipe through the levee, 8.4 feet below the crown. Concrete "U" headwalls on both the waterside (WS) and landside (LS) ends. Flap gate on the WS end. [Additional Reference(s): DWR Levee Log, 1993. USACE Sacramento O&M Manual 519, June 1962 (HLM 3.31)]

View of WS flap gate.

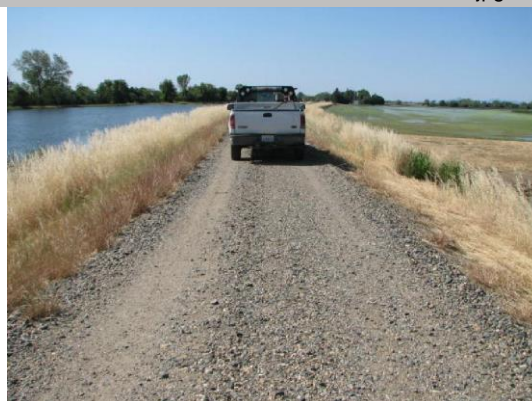
Photo 1 of 3 : UCIP_FA_2018_52190_66736.jpg

Overview of levee crown at crossing looking downstream.

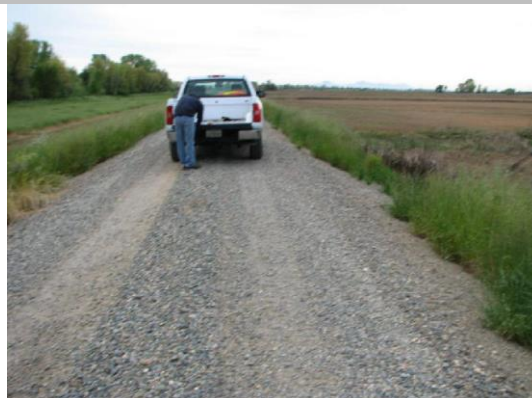
Photo 1 of 3 : UCIP_FA_2018_52194_66756.jpg

Overview of levee crown at crossing looking downstream at right bank of Cherokee Canal.

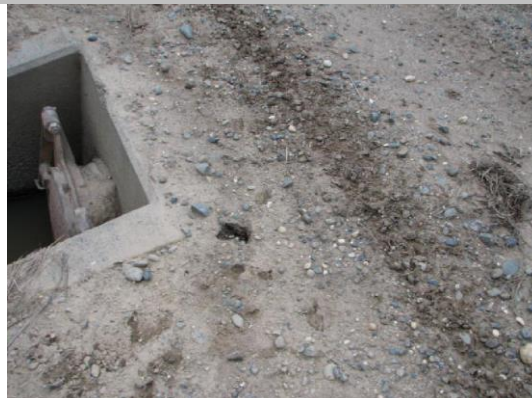
Photo 2 of 3 : UCIP_FA_2018_52194_66758.jpg

Burrow activity on WS slope.

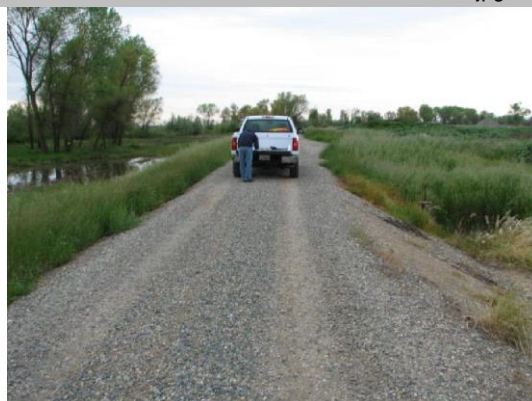
Photo 1 of 3 : UCIP_FA_2018_52195_66762.jpg

Overview of levee crown at crossing looking D/S on right bank of Cherokee Canal.

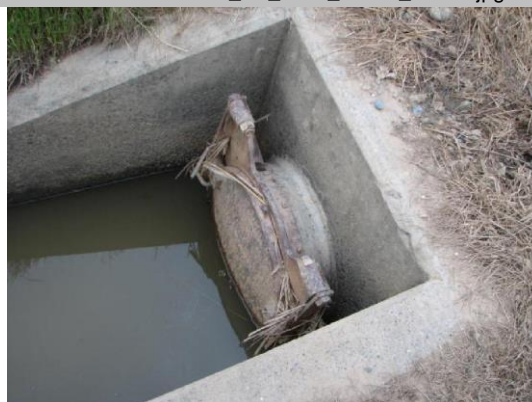
Photo 2 of 3 : UCIP_FA_2018_52195_66760.jpg

WS Flap Gate

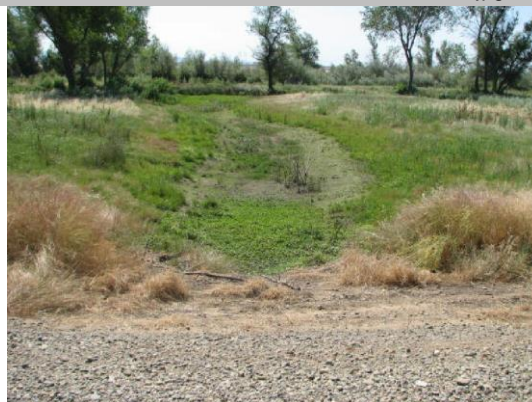
Photo 2 of 3 : UCIP_FA_2018_52201_66794.jpg

View of WS slope and toe.

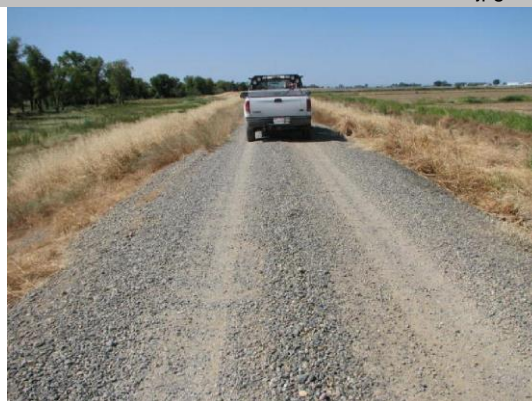
Photo 1 of 3 : UCIP_FA_2018_52203_66808.jpg

Comment Code						
Inspector Comment						
FS_ID:52203 DS_ID:16361 EP_NO: N/A Repair Type: Non-Urgent Crossing Status: Found UCIP Comments: 6/14/2017 WS appears to be in good condition. LS slide gate is buried and submerged. Pipe has been selected to be internally cleaned and inspected as part of the DMP project. (DWR Sutter Yard- AFreitag)11/16/2016 LS screwgate is buried and non-operational. (DWR Sutter Yard- AFreitag)4/28/2016 LS screwgate is still completely buried. 7/13/2015 LS screw gate is completely buried.5/21/2014 Same as last inspection.7/15/2013 WS slope has been cleared of vegetation and is in good condition. LS screw gate is still buried.12/2/2013 Same as last inspection.4/18/2012 LS slide gate is buried. Pipe is not visible on LS toe. Limited inspection on WS slope due to dense vegetation. FIELD_STRUCT_DESC: 24-inch corrugated metal drainage pipe through the levee, 7.4 feet below the crown. Flap gate on the waterside (WS) end. Slide gate on the landside (LS) end. Concrete "U" headwalls on both ends. [Additional Reference(s): DWR Levee Log, 1993. USACE Sacramento O&M Manual 519, June 1962 (HLM 6.34)] FS Date: 6/16/2017 1:51:41 PM

Overview of levee crown at crossing looking downstream.

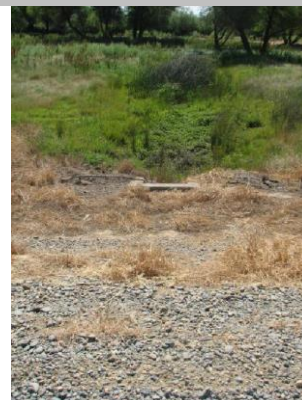
Photo 2 of 3 : UCIP_FA_2018_52203_66806.jpg

View of WS slope and toe.

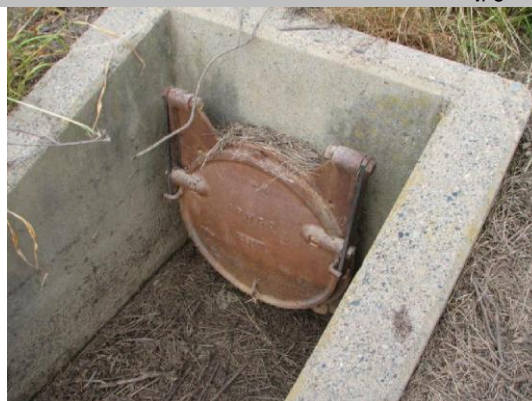
Photo 3 of 3 : UCIP_FA_2018_52203_66804.jpg

Comment Code						
Inspector Comment						
FS_ID:52203 DS_ID:16361 EP_NO: N/A Repair Type: Non-Urgent Crossing Status: Found UCIP Comments: 6/14/2017 WS appears to be in good condition. LS slide gate is buried and submerged. Pipe has been selected to be internally cleaned and inspected as part of the DMP project. (DWR Sutter Yard- AFreitag)11/16/2016 LS screwgate is buried and non-operational. (DWR Sutter Yard- AFreitag)4/28/2016 LS screwgate is still completely buried. 7/13/2015 LS screw gate is completely buried.5/21/2014 Same as last inspection.7/15/2013 WS slope has been cleared of vegetation and is in good condition. LS screw gate is still buried.12/2/2013 Same as last inspection.4/18/2012 LS slide gate is buried. Pipe is not visible on LS toe. Limited inspection on WS slope due to dense vegetation. FIELD_STRUCT_DESC: 24-inch corrugated metal drainage pipe through the levee, 7.4 feet below the crown. Flap gate on the waterside (WS) end. Slide gate on the landside (LS) end. Concrete "U" headwalls on both ends. [Additional Reference(s): DWR Levee Log, 1993. USACE Sacramento O&M Manual 519, June 1962 (HLM 6.34)] FS Date: 6/16/2017 1:51:41 PM

View of WS flap gate.

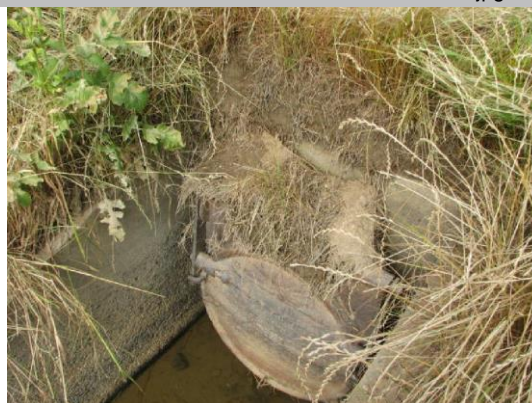
Photo 3 of 3 : UCIP_FA_2018_52211_66837.jpg

Comment Code						
Inspector Comment						
FS_ID:52211 DS_ID:16329 EP_NO: N/A Repair Type: Non-Urgent Crossing Status: Found UCIP Comments: 6/14/2017 LS slide gate is still damaged and needing to be replaced. WS appeared to be in good condition. Pipe has been selected to be internally cleaned and inspected as part of the DMP project. (DWR Sutter Yard- AFreitag)11/16/2016 Needs a new screw gate installed on the LS. (DWR Sutter Yard- AFreitag)4/28/2016 LS slide gate is still bent. Everyhting else with the crossing appeared ok.7/13/2015 LS screw gate needs to be replaced. Everything else with crossing seems to be in good condition.5/21/2014 Same as last inspection.12/2/2013 Same as last inspection.7/15/2013 Slopes have been cleared of vegetation and are in good condition. There were no apparent signs of settling. LS screw gate is still damaged.4/18/2012 LMA's inspection sheet of 2011 indicates settlement and visible corrosion. Damage/severe corrosion on screw gate where it bolts to headwall. No visible signs of settlement due to high vegetation cover. Limited inspection on WS and LS slopes due to dense vegetation. Need photos of cleared slopes for this crossing. FIELD_STRUCT_DESC: 24-inch corrugated metal drainage pipe through the levee, 9.8 feet below the crown. Flap gate on the waterside (WS) end. Slide gate on the landside (LS) end. Concrete headwall on both ends. [Additional Reference(s): DWR Levee Log, 1993. USACE Sacramento O&M Manual 519, June 1962 (HLM 7.10)] FS Date: 6/19/2017 10:17:38 AM

WS Flap Gate

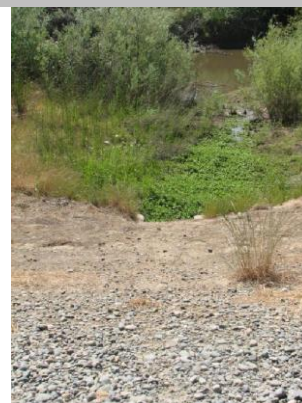
Photo 2 of 3 : UCIP_FA_2018_52212_66845.jpg

Comment Code						
Inspector Comment						
FS_ID:52212 DS_ID:16354 EP_NO: N/A Repair Type: Non-Urgent Crossing Status: Found UCIP Comments: 6/14/2017 LS slide gate stem still bent. WS appeared to be in good condition. Pipe has been selected to be internally cleaned and inspected as part of the DMP project. (DWR Sutter Yard- A Freitag)11/16/2016 Screw gate stem bent but gate is still operational. (DWR Sutter Yard- A Freitag)4/28/2106 Tested positive closure device the bent stem on the slide gate did not seem to affect its functions. Gate operable.7/13/2015 LS screw gate stem is still bent. Gate should still be able to close fully. The rest of the crossing seems to be in good condition.5/21/2014 Same as last inspection.12/2/2013 Same as last inspection.7/15/2013 Slopes have been cleared of vegetation and are in good condition. LS screw gate stem is still bent.4/18/2012 LS slide gate stem is bent and needs to be replaced. Limited inspection on WS and LS slope due to dense vegetation. Need photos of cleared slopes during next inspection. Confirmed flap gate on WS. This crossing was listed in the USACE Periodic Inspection report as Corp's inspect ID#USACE_CESPK_M13D_2011_p_0244 for submerged WS gate. FIELD_STRUCT_DESC: 24-inch corrugated metal drainage pipe through the levee, 11.2 feet below the crown. Flap gate on the waterside (WS) end. Slide gate on the landside (LS) end. Concrete "U" headwall on both ends. [Additional Reference(s): DWR Levee Log, 1993. USACE Sacramento O&M Manual 519, June 1962 (HLM 7.34)] FS Date: 6/19/2017 10:19:12 AM

View of WS slope and toe.

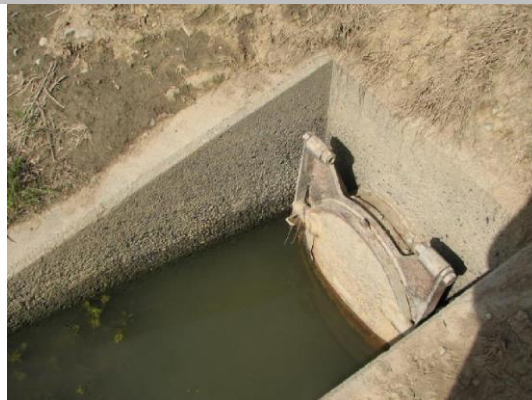
Photo 3 of 3 : UCIP_FA_2018_52212_66842.jpg

FS_ID:52212
DS_ID:16354
EP_NO: N/A
Repair Type: Non-Urgent
Crossing Status: Found
UCIP Comments: 6/14/2017 LS slide gate stem still bent. WS appeared to be in good condition. Pipe has been selected to be internally cleaned and inspected as part of the DMP project. (DWR Sutter Yard- A Freitag)11/16/2016 Screw gate stem bent but gate is still operational. (DWR Sutter Yard- A Freitag)4/28/2106 Tested positive closure device the bent stem on the slide gate did not seem to affect its functions. Gate operable.7/13/2015 LS screw gate stem is still bent. Gate should still be able to close fully. The rest of the crossing seems to be in good condition.5/21/2014 Same as last inspection.12/2/2013 Same as last inspection.7/15/2013 Slopes have been cleared of vegetation and are in good condition. LS screw gate stem is still bent.4/18/2012 LS slide gate stem is bent and needs to be replaced. Limited inspection on WS and LS slope due to dense vegetation. Need photos of cleared slopes during next inspection. Confirmed flap gate on WS. This crossing was listed in the USACE Periodic Inspection report as Corp's inspect ID#USACE_CESPK_M13D_2011_p_0244 for submerged WS gate. FIELD_STRUCT_DESC: 24-inch corrugated metal drainage pipe through the levee, 11.2 feet below the crown. Flap gate on the waterside (WS) end. Slide gate on the landside (LS) end. Concrete "U" headwall on both ends. [Additional Reference(s): DWR Levee Log, 1993. USACE Sacramento O&M Manual 519, June 1962 (HLM 7.34)]

WS Flap Gate

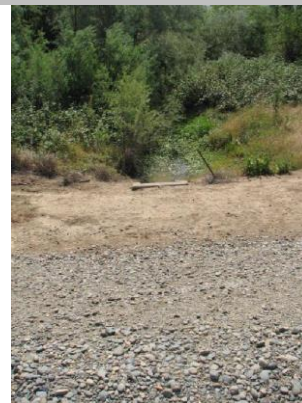
Photo 2 of 3 : UCIP_FA_2018_52219_66874.jpg

View of WS slope and toe.

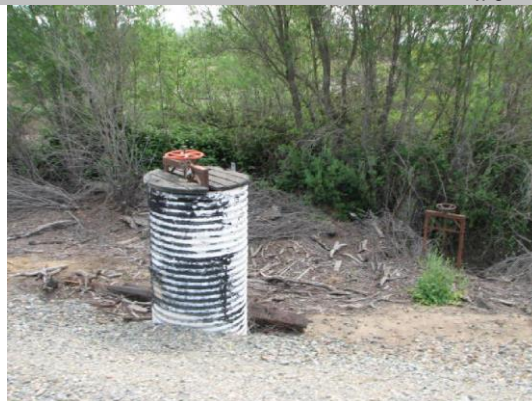
Photo 2 of 3 : UCIP_FA_2018_52223_66897.jpg

View of WS slope with 2 slide gates.

Comment Code						
Inspector Comment						
FS_ID:52223 DS_ID:16325 EP_NO: N/A Repair Type: Non-Urgent Crossing Status: Found UCIP Comments: 6/14/2017 Debris drifts built up around the WS slide gates- needs to be cleared away. LS appears to be n good condition. Pipe has been selected to be internally cleaned and inspected as part of the DMP project. (DWR Sutter Yard- AFreitag)11/16/2016 Crossing appears to be in good condition. (DWR Sutter Yard- AFreitag)4/28/2016 Crossing appears to be in good condition.7/13/2015 Crossing appears in good condition. No noticeable issues to report.5/21/2014 Same as last inspection.12/3/2013 Same as last inspection.7/15/2013 LS slope has been sprayed and cleared of vegetation and is in good condition.4/18/2012 Limited inspection on LS slope due to dense vegetation. Need photo of cleared vegetation from slopes and WS headwall. Minor debris scattered on WS slope. FIELD_STRUCT_DESC: 24-inch corrugated metal drainage pipe through the levee, 12.6 feet below the crown. Slide gate in corrugated metal pipe riser on the waterside (WS) slope. Slide gate on the WS end. Concrete "U" headwall on both ends. [Additional Reference(s): DWR Levee Log, 1993. USACE Sacramento O&M Manual 519, June 1962 (HLM 8.98)] FS Date: 6/19/2017 12:59:24 PM

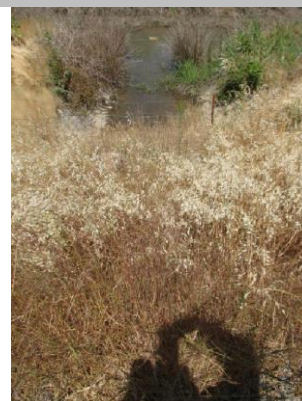
Photo 3 of 3 : UCIP_FA_2018_52227_66912.jpg

Item	DWR UCIP LMA Responsibility			39.476839 °	39.476839 °	
				-121.737540 °	-121.737540 °	
DWR ID	16317					
Comment Code						
Inspector Comment						
FS_ID:52227 DS_ID:16317 EP_NO: N/A Repair Type: No Action Needed Crossing Status: Found UCIP Comments: 6/14/2017 Crossing appears to be in good condition. Pipe has been selected to be internally cleaned and inspected as part of the DMP project. (DWR Sutter Yard- A Freitag)11/16/2016 Crossing appears to be in good condition. (DWR Sutter Yard- A Freitag)4/28/2016 Crossing appears to be in good condition.7/13/2015 LS inlet has minor vegetation still. WS appears in good condition.5/21/2014 Same as last inspection.12/3/2013 Same as last inspection.7/15/2013 Slopes have been cleared of vegetation and are in good condition.4/18/2012 Limited inspection on WS and LS slopes due to dense vegetation. Need photos of cleared WS and LS slopes. This crossing was listed in the USACE Periodic Inspections as Corp's Insect ID# USACE_CESPK_M13D_2011_p_0278 for WS outlet sedimentation and sediment/grass at LS inlet. FIELD_STRUCT_DESC: 36-inch corrugated metal drainage pipe through the levee, 10.2 feet below the crown. Flap gate on the waterside (WS) end. Concrete "U" headwalls on both ends. Flashboards should be present on the landside (LS). [Additional Reference(s): DWR Levee Log, 1993. USACE Sacramento O&M Manual 519, June 1962 (HLM 9.09)] FS Date: 6/19/2017 1:09:21 PM

View of LS slope and toe.

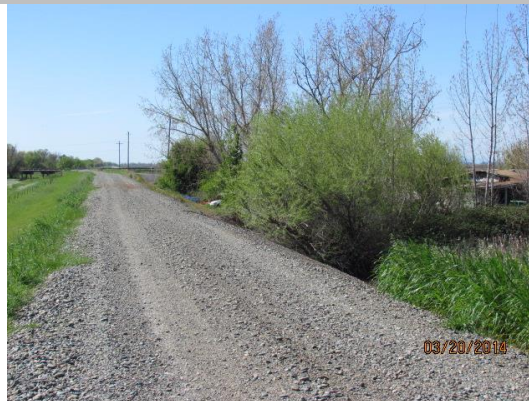
Photo 1 of 1 : FA_2018_MA0013_300_5_20180905_00002.jpg

LM Start	9.70	Rating **	M	Issue No.	5
LM End	9.72	Issue Type +	Ma	Location *	LS
Category	Earthen Levee			GPS Latitude/Longitude	
				Start	End
Item	Trim / Thin Trees			39.467170 °	39.466860 °
				-121.743887 °	-121.744108 °
DWR ID	DWR_MA0013_01_s_2012_5				
Comment Code					
T1 : Trim trees to at least five feet above ground level.					
Inspector Comment

View of the overgrown trees along the landside slope and toe.

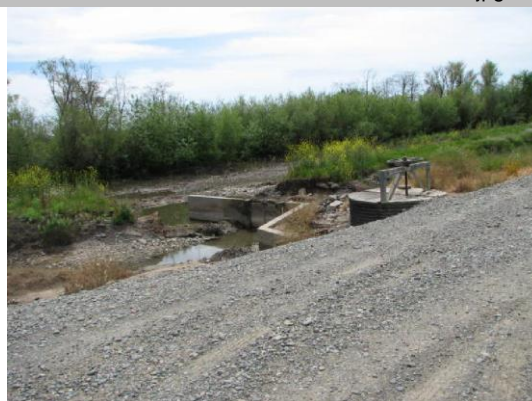
Photo 1 of 3 : UCIP_FA_2018_52232_66926.jpg

Comment Code					
Inspector Comment					
FS_ID:52232					
DS_ID:16332					
EP_NO: N/A					
Repair Type: No Action Needed					
Crossing Status: Found					
UCIP Comments: 6/15/2017 Crossing appears to be in good condition.					
Pipe has been selected to be internally cleaned and inspected as part					
of the DMP project. (DWR Sutter Yard- AFreitag)11/16/2016 Crossing					
appears to be in good condition. (DWR Sutter Yard-					
AFreitag)4/28/2016 Crossing appears to be in good					
condition.7/13/2015 Crossing appears in good condition. No					
noticeable issues to report.5/21/2014 Same as last					
inspection.12/3/2013 Same as last inspection.7/15/2013 Same as					
last inspection.					
FIELD_STRUCT_DESC: 60-inch corrugated metal drainage pipe					
through the levee, 11.5 feet below the crown. Slide gate in corrugated					
metal pipe riser on the waterside (WS) slope. Concrete "U" headwall on					
both ends and weir in channel. Crossing is used as an irrigation turnout.

View of WS corrugated metal riser and concrete wall.

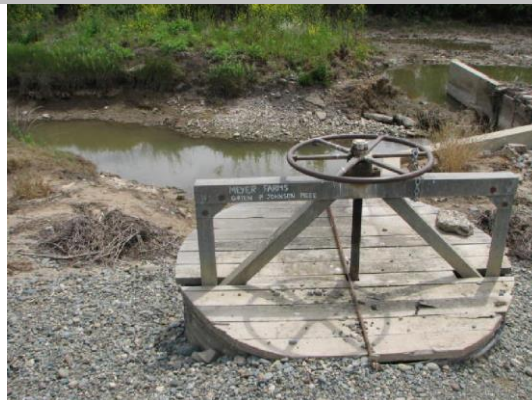
Photo 2 of 3 : UCIP_FA_2018_52232_66925.jpg

Corrugated metal riser with owner information.

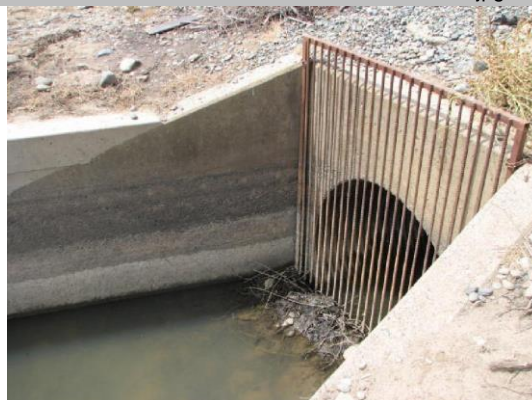
Photo 3 of 3 : UCIP_FA_2018_52232_66928.jpg

Trash rack on WS headwall.

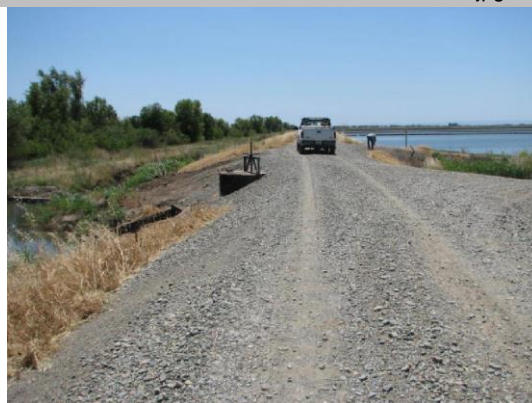
Photo 1 of 3 : UCIP_FA_2018_52233_66934.jpg

Comment Code					
Inspector Comment					
FS_ID:52233 DS_ID:16333 EP_NO: N/A Repair Type: No Action Needed Crossing Status: Found UCIP Comments: 6/15/2017 Crossing appears to be in good condition. Pipe has been selected to be internally cleaned and inspected as part of the DMP project. (DWR Sutter Yard- AFreitag)11/17/2016 Crossing appears to be in good condition. (DWR Sutter Yard- AFreitag)4/28/2016 Crossing appears to be in good condition.7/13/2015 Crossing appears in good condition. No noticeable issues to report.5/21/2014 Same as last inspection.12/3/2013 Same as last inspection.7/15/2013 Same as last inspection. FIELD_STRUCT_DESC: 60-inch corrugated metal drainage pipe through the levee, 11.3 feet below the crown. Slide gate in corrugated metal pipe riser on the waterside (WS) slope. Concrete "U" headwall on both ends. Crossing is used as an irrigation turnout bar code plate located on the WS slide gate (identified as 145). [Additional Reference(s): DWR Levee Log, 1993. USACE Sacramento O&M Manual 519, June 1962 (HLM 11.78)] FS Date: 6/19/2017 1:20:52 PM

Overview of levee crown at crossing looking downstream.

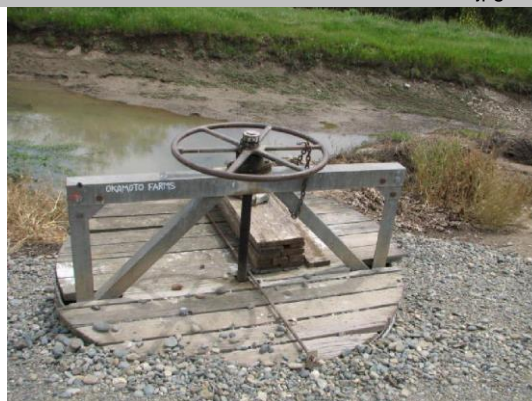
Photo 2 of 3 : UCIP_FA_2018_52233_66932.jpg

WS slide gate with owner information.

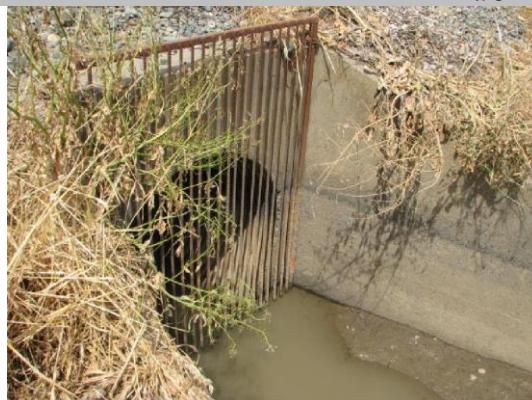
Photo 3 of 3 : UCIP_FA_2018_52233_66930.jpg

Trash rack on WS headwall.

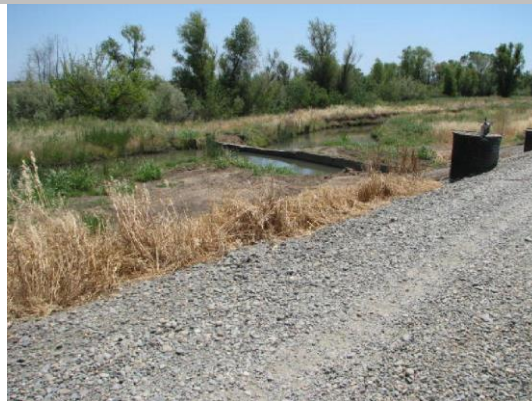
Photo 2 of 3 : UCIP_FA_2018_52234_66936.jpg

View of WS slope and channel.

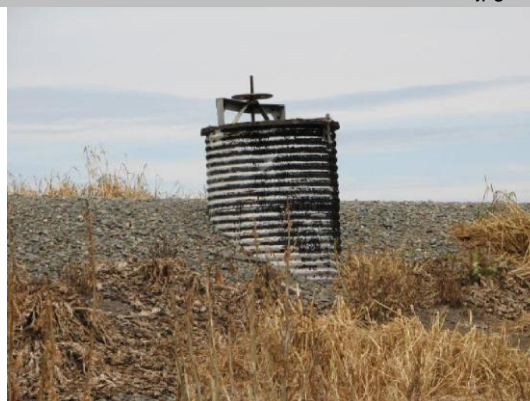
Photo 3 of 3 : UCIP_FA_2018_52234_66939.jpg

Item	DWR UCIP LMA Responsibility			39.435169 °	39.435169 °	
				-121.765290 °	-121.765290 °	
DWR ID	16334					
Comment Code						
Inspector Comment						
FS_ID:52234 DS_ID:16334 EP_NO: N/A Repair Type: Non-Urgent Crossing Status: Found UCIP Comments: 6/15/2017 WS pipe end still unknown- try to locate using GPR/ utility locator. Pipe has been selected to be internally cleaned and inspected as part of the DMP project. (DWR Sutter Yard- A Freitag)11/17/2016 Cannot locate the WS pipe end. (DWR Sutter Yard- A Freitag)4/28/2016 Crossing appears to be in good condition but could not locate the WS pipe end.7/13/2015 New screw gate installed inside the WS standpipe. 5/21/2014 Same as last inspection.12/3/2013 Same as last inspection.7/15/2013 Slopes have been cleared of vegetation and are in good condition. Still no sign of WS end of pipe.4/18/2012 Limited inspection on WS and LS slope due to dense vegetation. WS outlet of pipe not found. Need photos of cleared WS and LS slopes. Determine if WS outlet daylights after WS slope is cleared. FIELD_STRUCT_DESC: 30-inch corrugated metal drainage pipe through the levee, 11 feet below the crown. Slide gate in corrugated metal pipe riser on the waterside (WS) slope. Concrete "U" headwall on the landside (LS). [Additional Reference(s): DWR Levee Log, 1993. USACE Sacramento O&M Manual 519, June 1962 (HLM 12.38)] FS Date: 6/19/2017 1:22:23 PM

Slide gate located on WS slope.

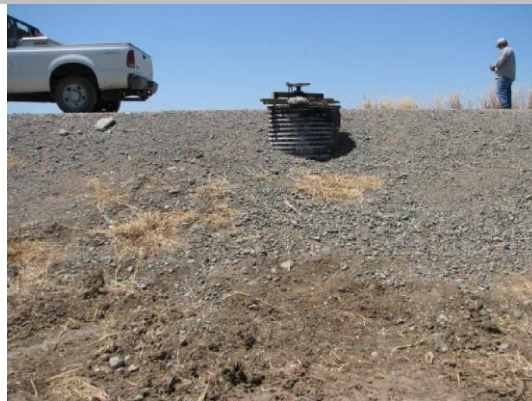
Photo 2 of 3 : UCIP_FA_2018_52236_66959.jpg

View of WS slope.

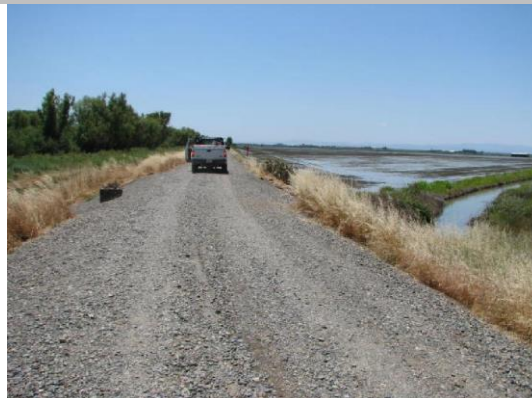
Photo 1 of 3 : UCIP_FA_2018_52238_66966.jpg

Comment Code					
Inspector Comment					
FS_ID:52238 DS_ID:16337 EP_NO: N/A Repair Type: No Action Needed Crossing Status: Found UCIP Comments: 6/15/2017 Crossing appears to be in good condition. Pipe has been selected to be internally cleaned and inspected as part of the DMP project. (DWR Sutter Yard- A Freitag)11/17/2016 Ws pipe end was submerged but crossing appears to be in good condition. (DWR Sutter Yard- A Freitag)5/03/2016 Crossing appears to be in good condition. 7/13/2015 New screwgate installed inside of WS standpipe.5/21/2014 Same as last inspection.12/3/2013 Same as last inspection. 7/15/2013 Same as last inspection. FIELD_STRUCT_DESC: 24-inch corrugated metal drainage pipe through the levee, 11.1 feet below the crown. Slide gate in corrugated metal pipe (CMP) riser on the waterside (WS) slope. Concrete "U" headwalls on both ends. [Additional Reference(s): DWR Levee Log, 1993. USACE Sacramento O&M Manual 519, June 1962 (HLM 13.53)] FS Date: 6/19/2017 1:33:59 PM

Overview of levee crown at crossing looking downstream.

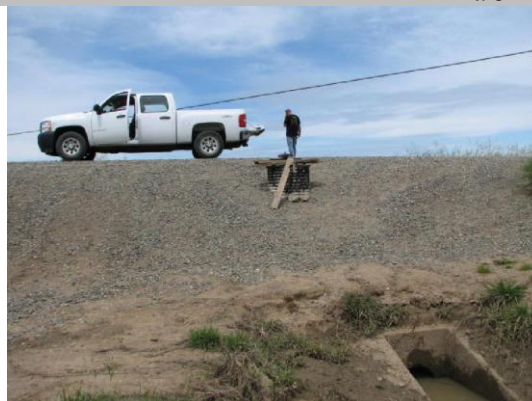
Photo 2 of 3 : UCIP_FA_2018_52238_66963.jpg

View of WS slope.

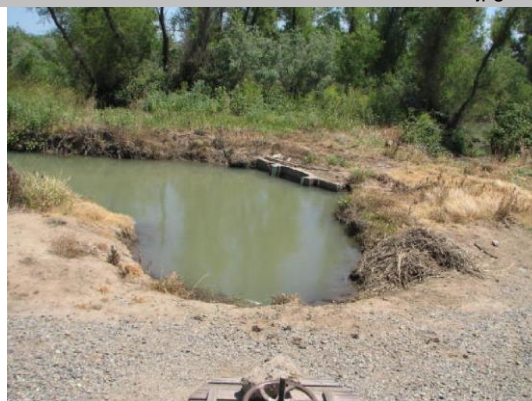
Photo 3 of 3 : UCIP_FA_2018_52238_66967.jpg

View of WS slope and channel.

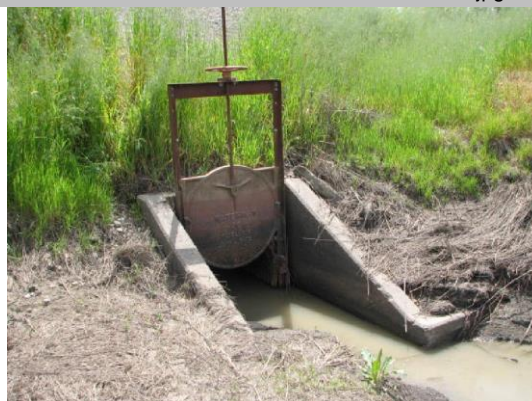
Photo 3 of 3 : UCIP_FA_2018_53317_66975.jpg

Head wall and screw gate located on land side of levee

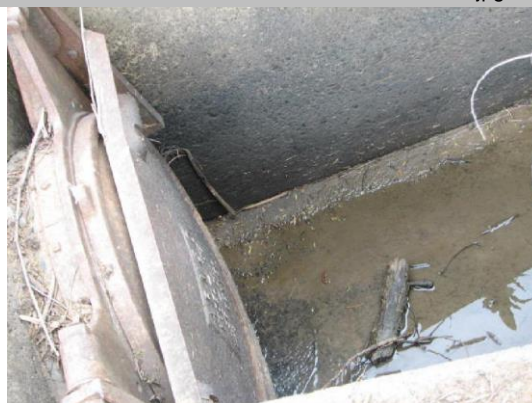
Photo 1 of 3 : UCIP_FA_2018_52242_66981.jpg

FS_ID:52242
DS_ID:16367
EP_NO: N/A
Repair Type: No Action Needed
Crossing Status: Found
UCIP Comments: 6/15/2017 Crossing appears to be in good condition. Pipe has been selected to be internally cleaned and inspected as part of the DMP project. (DWR Sutter Yard- A Freitag) 11/17/2016 Crossing appears to be in good condition. (DWR Sutter Yard- A Freitag) 5/03/2016 Crossing appears to be in good condition. 7/13/2015 Crossing appears in good condition. No noticeable issues to report. 5/22/2014 Same as last inspection. 12/3/2013 Same as last inspection. 7/15/2013 Slopes have been cleared of vegetation and are in good condition. 4/18/2012 Limited inspection on WS and LS slope due to dense vegetation. Need overall photo of crossing and photos of cleared WS & LS slopes. FIELD_STRUCT_DESC: 36-inch corrugated metal drainage pipe through the levee, 12.4 feet below the crown. Concrete "U" headwalls on both waterside (WS) and landside (LS). Flap gate on the waterside (WS) end. [Additional Reference(s): DWR Levee Log, 1993. USACE Sacramento O&M Manual 519, June 1962 (HLM 15.12)]

WS headwall and flapgate

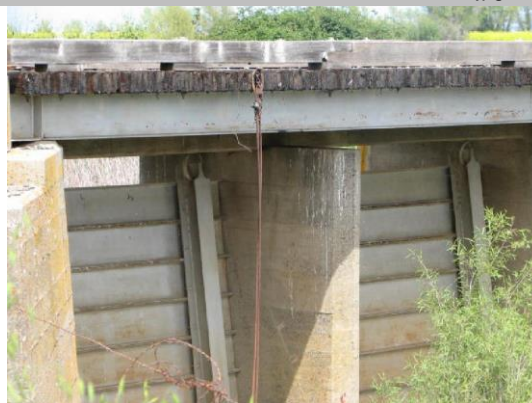
Photo 2 of 3 : UCIP_FA_2018_52245_74503.jpg

View of crossing and panels attached to concrete walls.

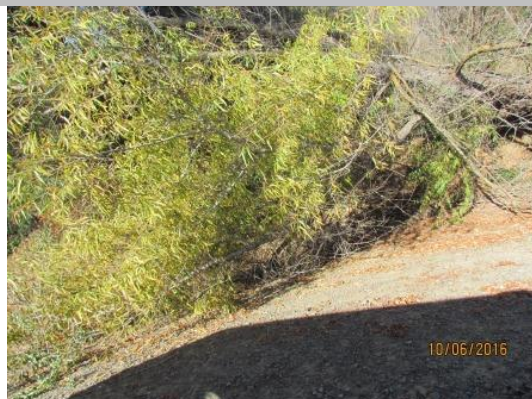
Photo 1 of 1 : FA_2018_MA0013_300_56_20180905_00008.jpg

LM Start	16.52	Rating **	M	Issue No.	56
LM End	16.52	Issue Type +	Ma	Location *	LS
Category	Earthen Levee			GPS Latitude/Longitude	
				Start	End
Item	Trim / Thin Trees			39.391675 °	39.391675 °
				-121.821932 °	-121.821932 °
DWR ID	DWR_MA0013_01_f_2016_56				
Comment Code					
T1 : Trim trees to at least five feet above ground level.					
Inspector Comment

View of dense trees along the landside toe.

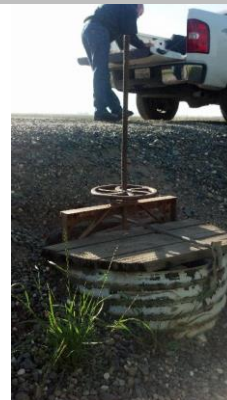
Photo 3 of 3 : UCIP_FA_2018_52112_67045.jpg

Screw gate located on WS of levee. Screw gate covers needs to be repaired.

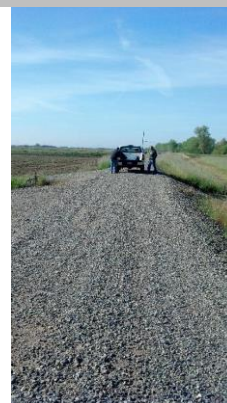
Photo 1 of 3 : UCIP_FA_2018_52115_67063.jpg

Comment Code					
Inspector Comment					
FS_ID:52115 DS_ID:16400 EP_NO: N/A Repair Type: No Action Needed Crossing Status: Found UCIP Comments: 6/5/2017 LS inlet was underwater. WS flapgate blocked shut by sediment. Pipe has been selected to be internally cleaned and inspected as part of the DMP project. (DWR Sutter Yard-AFreitag)11/18/2016 Sediment dug out from in front of flap gate. Gate can now function properly. (DWR Sutter Yard-AFreitag)4/27/2016 WS flapgate still blocked from opening by sediment buildup.7/01/2015 New screwgate installed on the LS. WS flapgate is still blocked from opening by sediment.5/29/2014 Same as last inspection.12/9/2013 Same as last inspection.7/10/2013 Sediment is built up against WS flap gate not allowing it to open. Handle for LS slide gate is still missing.4/19/2012 Handle missing on slide gate. FIELD_STRUCT_DESC: 1 of 2: 36-inch corrugated metal drainage pipe through the levee, 9.7 feet below the crown. Concrete "U" headwalls located on the waterside (WS) and landside (LS) ends. Flap gate on the WS end. Slide gate on the LS end. [Additional Reference(s): DWR Levee Log, 1993. USACE Sacramento O&M Manual 519, June 1962 (HLM 2.54)] FS Date: 6/7/2017 12:18:14 PM

Overview of levee crown looking south

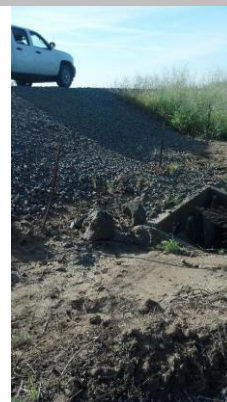
Photo 2 of 3 : UCIP_FA_2018_52116_67074.jpg

View of WS slope.

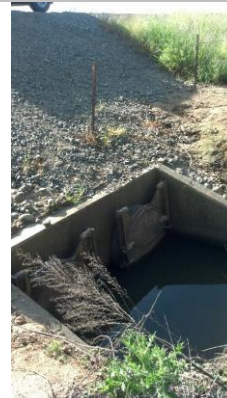
Photo 3 of 3 : UCIP_FA_2018_52116_67071.jpg

Headwall and flap gates (2) located on the WS.

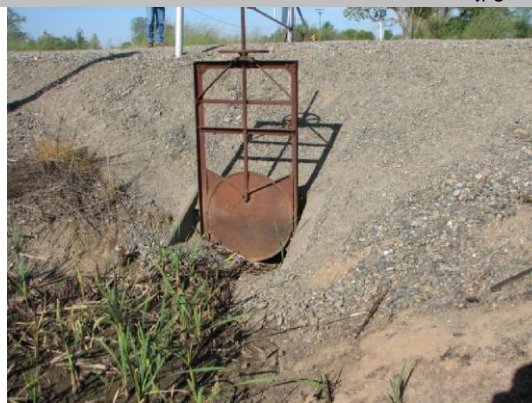
Photo 3 of 3 : UCIP_FA_2018_52117_67078.jpg

FS_ID:52117
DS_ID:16402
EP_NO: N/A
Repair Type: Non-Urgent
Crossing Status: Found
UCIP Comments: 6/5/2017 Sediment blocking LS slide gate from closing fully. Pipe has been selected to be internally cleaned and inspected as part of the DMP project. (DWR Sutter Yard- A Freitag)11/18/2016 Sediment still blocking screw gate from fully closing. (DWR Sutter Yard- A Freitag)4/27/2016 LS slide gate is full of sediment and needs to be dug out so gate can close fully.7/01/2015 LS screwgate is still silted in and unable to be screwed down all the way. Needs to be cleaned out.5/29/2014 Same as last inspection.12/9/2013 WS flapgate was closed but LS slidegate is heavily vegetated and blocked from closing by sediment.7/10/2013 Same as last inspection.4/19/2012 Minor sediment built up on LS, remove sediment. Need photo of LS slide gate without sediment build up. This crossing was listed in the USACE Periodic Inspection report as Corp's inspect ID# USACE_CESPK_M13G_2011_p_0148 for LS gate obstructed by vegetation and WS flap gate is not functioning (propped open).

Headwall and screw gate located on LS.

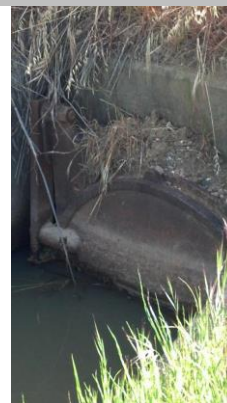
Photo 2 of 3 : UCIP_FA_2018_52119_67084.jpg

Headwall and flap gate located on WS

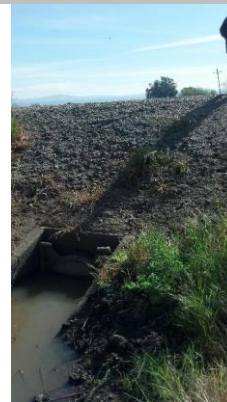
Photo 2 of 3 : UCIP_FA_2018_52120_67091.jpg

Headwall and flap gate located on WS.

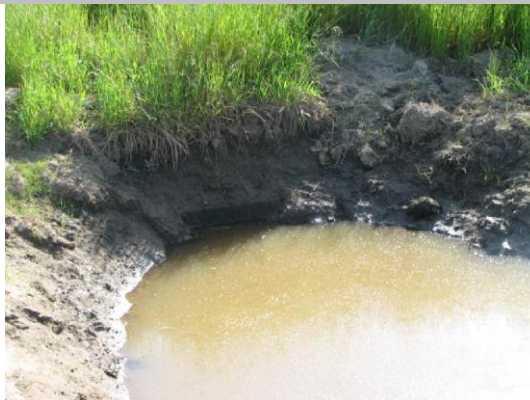
Photo 3 of 3 : UCIP_FA_2018_52121_67096.jpg

7/10/2013 LS and WS slopes have been cleared by vegetation and are in good condition. WS flap gate is out of water but is blocked from opening by sediment build up. LS gate is fully submerged and not able to be inspected.4/19/2012 Non-functioning crossing. Farmer uses pipe located at LM 3.682 to drain field & not this one. Dense vegetation-need photos of cleared WS & LS slopes. This crossing was listed in the USACE Periodic Inspection report as Corp's inspect ID# USACE_CESPK_M13G_2011_p_0172 for no access to WS gate due to high water & dense vegetation.

View of flap gate submerged on WS toe.

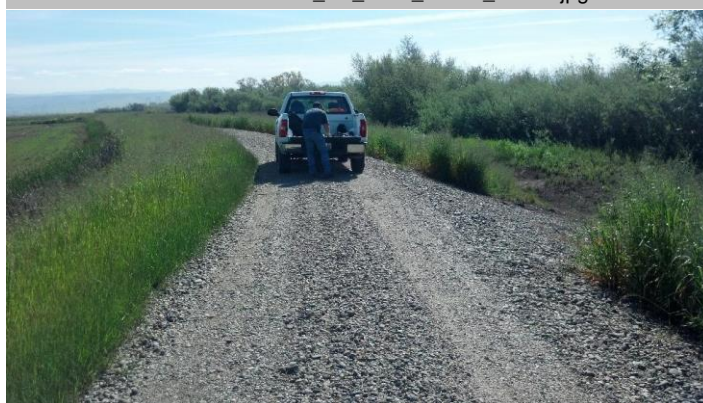
Photo 1 of 3 : UCIP_FA_2018_52122_67102.jpg

UCIP Comments: 6/5/2017 Both ends submerged but appear to be in good condition. Pipe has been selected to be internally cleaned and inspected as part of the DMP project. (DWR Sutter Yard- A/Freitag)11/18/2016 Crossing appears to be in good condition. (DWR Sutter Yard- A/Freitag)4/27/2016 Crossing appears to be in good condition. New slide gate installed on LS.7/01/2015 Both gates were still submerged in water. Levee slopes were in good condition.5/29/2014 Same as last inspection.12/9/2013 Same as last inspection.7/10/2013 LS slope has been cleared of vegetation and is in good condition. Both gates are still underwater and not able to be inspected.4/19/2012 Dense vegetation makes it difficult to evaluate the condition of the LS slope. Both gates underwater. Recommend taking photos of clear slopes and gates during fall inspection.

Overview looking south on left levee

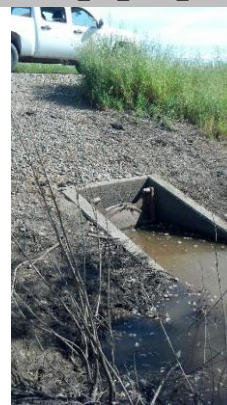
Photo 2 of 3 : UCIP_FA_2018_52122_67103.jpg

Headwall and flap gate located on WS.

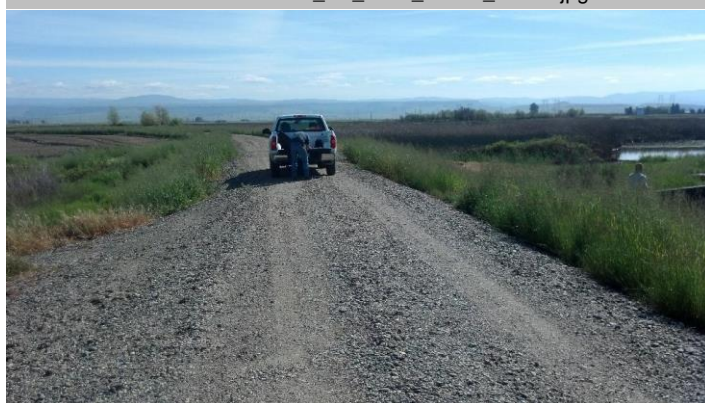
Photo 1 of 3 : UCIP_FA_2018_52123_67107.jpg

FS_ID:52123
DS_ID:16847
EP_NO: N/A
Repair Type: Non-Urgent
Crossing Status: Found
UCIP Comments: 6/5/2017 Both ends submerged but crossing appears to be in good condition. (DWR Sutter Yard- AFreitag)11/18/2016 Crossing appears to be in good condition. It appears that this crossing does not require a slide gate. (DWR Sutter Yard- AFreitag)4/27/2016 LS slide gate was still missing. Rest of crossing appears to be in good condition.7/01/2015 There appears to be a LS gate now but both pipe ends were submerged so it was hard to tell for certain.5/29/2014 Same as last inspection.12/9/2013 Pulled sticks from WS flap gate to allow it to close. Ls gate is still missing.7/10/2013 WS and LS slopes have been cleared of vegetation and are in good condition. LS gate is still missing and WS flap gate is still wedged open with sticks.4/19/2012 LS gate missing & limited inspection. Need photos of WS & LS cleared slopes. Description calls for slide gate on LS-slide gate missing. Debris scattered near LS headwall. This crossing was listed in the USACE Periodic Inspection report as Corp's Inspect ID# USACE_CESPK_M13J_2011_p_0010 for WS gate wedged open & missing LS slide gate.

Overview looking south on left levee

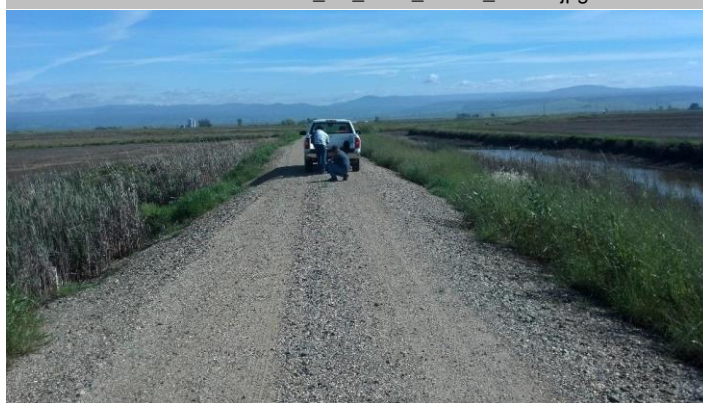
Photo 1 of 3 : UCIP_FA_2018_52124_67115.jpg

Comment Code						
Inspector Comment						
FS_ID:52124 DS_ID:16846 EP_NO: N/A Repair Type: Non-Urgent Crossing Status: Found UCIP Comments: 6/5/2017 Both ends submerged during site visit. Pipe has been selected to be internally cleaned and inspected as part of the DMP project. (DWR Sutter Yard- AFreitag)11/18/2016 Both pipe ends underwater for this inspection. (DWR Sutter Yard- AFreitag)4/27/2016 Both pipe ends were underwater for inspection.7/01/2015 Both pipe ends and gates were fully submerged.5/29/2014 Same as last inspection.12/9/2013 Same as last inspection.7/10/2013 WS slope is cleared of vegetation and is in good condition. Both gates were fully submerged under water and unable to be inspected.4/19/2012 Rodent activity caused partial collapse on LS of levee in the vicinity of pipe. Limited inspection on WS slope due to dense vegetation. Limited inspection on gates due to both gates submerged under water. FIELD_STRUCT_DESC: 36-inch corrugated metal drainage pipe through the levee, 9.3 feet below the crown. Flap gate on the waterside (WS) end. Slide gate on the landside (LS) end. Concrete "U" headwalls on both ends. Concrete sump area with flash boards to drain farmers field is located on farmer's property near drain inlet. [Additional Reference(s): DWR Levee Log, 1993. USACE Sacramento O&M Manual 519, June 1962 (HLM 4.20)] FS Date: 6/7/2017 1:27:00 PM

Overview looking east on right bank of Cottonwood

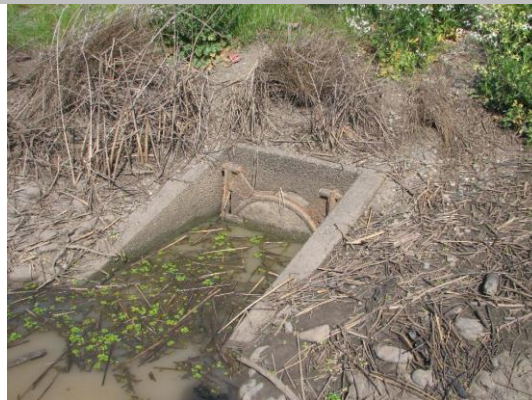
Photo 2 of 3 : UCIP_FA_2018_52124_67116.jpg

Unable to determine condition of flap gate on WS due to high water.

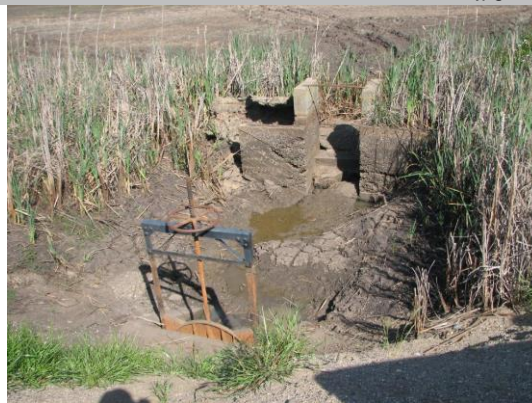
Photo 3 of 3 : UCIP_FA_2018_52124_67113.jpg

Overview of LS screw gate and concrete sump structure.

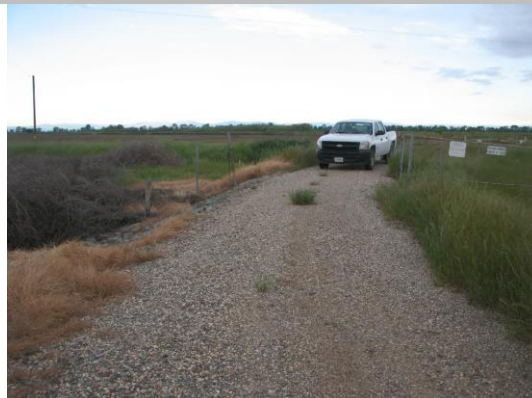
Photo 1 of 3 : UCIP_FA_2018_52126_67131.jpg

FS_ID:52126
DS_ID:16395
EP_NO: N/A
Repair Type: No Action Needed
Crossing Status: Found
UCIP Comments: 6/5/2017 WS mostly submerged but crossing appears to be in good condition.(DWR Sutter Yard- AFreitag)11/18/2016 Crossing appears to be in good condition. Pipe is a 30" cmp. (DWR Sutter Yard- AFreitag)4/27/2016 Crossing appears to be in good condition.6/30/2015 Erosion on LS does not appear to be getting any worse with the rip-rap there. WS pipe end and gate appeared in good condition.5/29/2014 Same as last inspection.12/9/2013 Same as last inspection.7/09/2013 Same as last inspection.4/19/2012 Rusted pipe debris located on WS. Remove pipe debris on WS and monitor the LS erosion near headwall. Rip-rap used to protect LS headwall from erosion. Was pipe exposed prior to dumping rock? Erosion on the LS could have exposed pipe. Dense shrub on the LS could restrict flow.
FIELD_STRUCT_DESC: 30-inch corrugated metal drainage pipe through the levee, 8.6 feet below the crown. Flap gate on the waterside (WS) end. Concrete "U" headwalls on both ends. [Additional Reference(s): DWR Levee Log, 1993. USACE Sacramento O&M Manual 519, June 1962 (HLM 5.06)]

Overview looking west on the left levee of Cottonwood

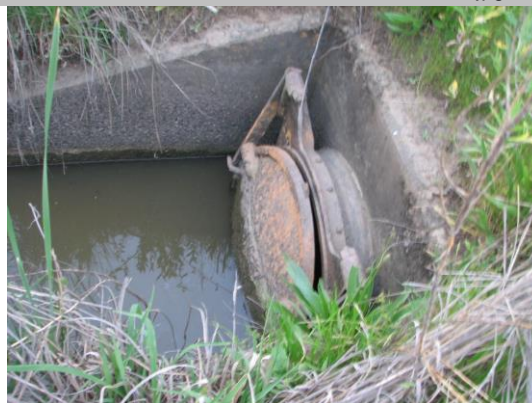
Photo 2 of 3 : UCIP_FA_2018_52126_67129.jpg

Headwall and flap gate located on WS.

Item	DWR UCIP LMA Responsibility			39.526298 °	39.526298 °	
				-121.688320 °	-121.688320 °	
DWR ID	16395					
Comment Code						
Inspector Comment						
FS_ID:52126						
DS_ID:16395						
EP_NO: N/A						
Repair Type: No Action Needed						
Crossing Status: Found						
UCIP Comments: 6/5/2017 WS mostly submerged but crossing appears to be in good condition.(DWR Sutter Yard-AFreitag)11/18/2016 Crossing appears to be in good condition. Pipe is a 30" cmp. (DWR Sutter Yard- AFreitag)4/27/2016 Crossing appears to be in good condition.6/30/2015 Erosion on LS does not appear to be getting any worse with the rip-rap there. WS pipe end and gate appeared in good condition.5/29/2014 Same as last inspection.12/9/2013 Same as last inspection.7/09/2013 Same as last inspection.4/19/2012 Rusted pipe debris located on WS. Remove pipe debris on WS and monitor the LS erosion near headwall. Rip-rap used to protect LS headwall from erosion. Was pipe exposed prior to dumping rock? Erosion on the LS could have exposed pipe. Dense shrub on the LS could restrict flow.

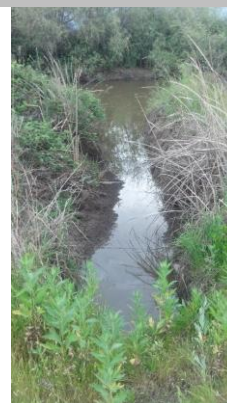
Photo 3 of 3 : UCIP_FA_2018_52126_67126.jpg

View of channel at crossing.

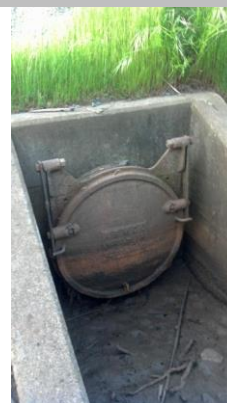
Photo 3 of 3 : UCIP_FA_2018_52130_67148.jpg

Headwall and flap gate located on WS.

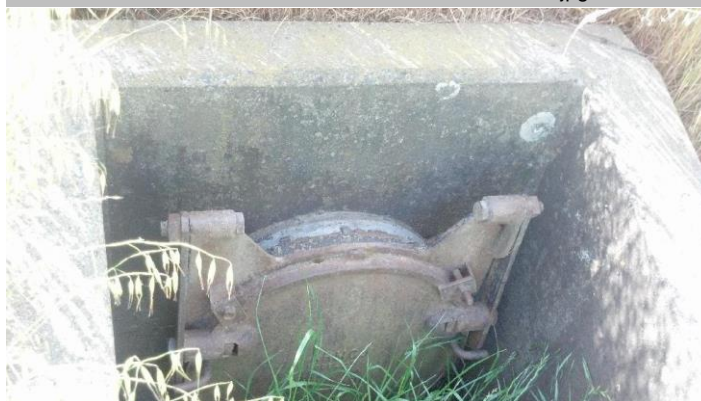
Photo 3 of 3 : UCIP_FA_2018_52156_67342.jpg

View of WS headwall and flap gate.

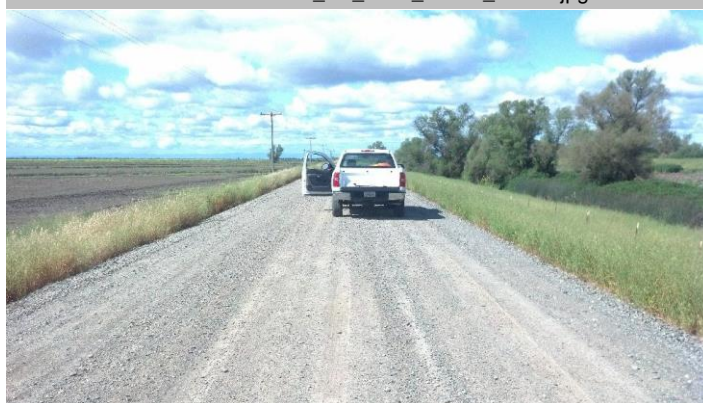
Photo 1 of 3 : UCIP_FA_2018_52157_67352.jpg

UCIP Comments: 5/30/2017 LS pipe end is buried and location unknown. WS flap gate bolted shut. Pipe has been selected to be internally cleaned and inspected as part of the DMP project. (DWR Sutter Yard- A Freitag)11/17/2016 Unable to locate LS pipe end. WS flap gate bolted shut. (DWR Sutter Yard- A Freitag)4/26/2016 Appears to be an abandoned crossing. LS pipe end was still buried and WS flap gate was bolted shut.6/30/2015 LS headwall stil buried somewhere. WS looked to be in good condition.5/28/2014 Same as last inspection.12/4/2013 Same as last inspection.7/08/2013 Same as last inspection.4/24/2012 LS headwall buried. Limited inspection on WS and LS slopes due to dense vegetation. Need photos of cleared WS and LS slopes during next inspection. Need to determine the fate of LS headwall. This crossing was listed in the USACE Periodic Inspection report as Corp's inspect ID# USACE_CESPK_M13E_2011_p_0022 -- unknown issue.

Overview of crossing looking downstream of the left bank of Cherokee

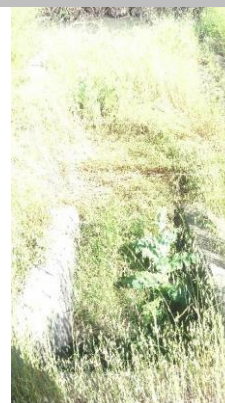
Photo 3 of 3 : UCIP_FA_2018_52157_67350.jpg

View of WS headwall.

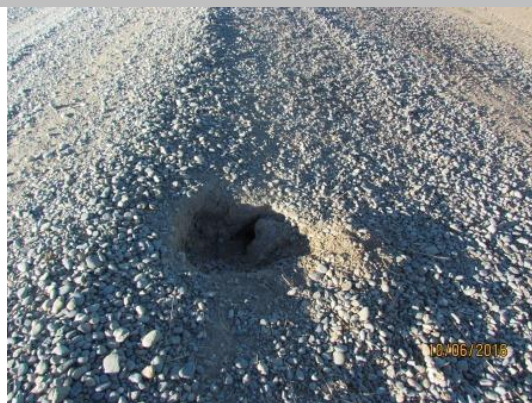
Photo 1 of 1 : FA_2018_MA0013_301_54_20180905_00012.jpg

LM Start	16.52	Rating **	M	Issue No.	54
LM End	16.52	Issue Type +	Ma	Location *	WS
Category	Earthen Levee			GPS Latitude/Longitude	
				Start	End
Item	Animal Control			39.409548 °	39.409548 °
				-121.789668 °	-121.789668 °
DWR ID	DWR_MA0013_02_f_2014_54				
Comment Code					
A3 : No rodents visible, but rodent burrows visible; need to backfill and compact or grout burrows.					
Inspector Comment

View of the rodent holes along the waterside slope.

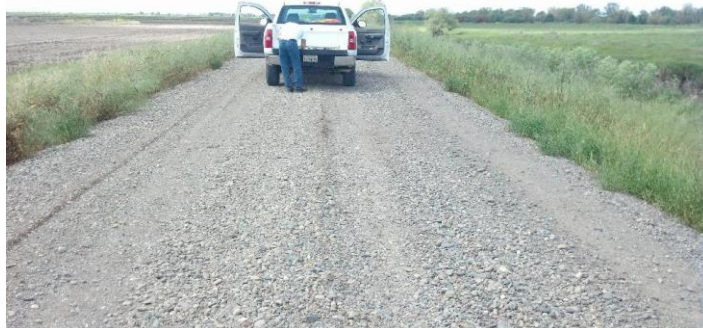
Photo 1 of 3 : UCIP_FA_2018_52161_67387.jpg

FS_ID:52161
DS_ID:16379
EP_NO: N/A
Repair Type: No Action Needed
Crossing Status: Found
UCIP Comments: 5/30/2017 Crossing appears to be in good condition. Pipe has been selected to be internally cleaned and inspected as part of the DMP project. (DWR Sutter Yard- A Freitag) 11/17/2016 Crossing appears to be in good condition. (DWR Sutter Yard- A Freitag) 4/26/2016 Crossing appears to be in good condition. 6/30/2015 Vegetation still present on WS. LS side was underwater during inspection. 5/28/2014 Same as last inspection. 12/4/2013 Same as last inspection. 7/08/2013 LS slope cleared of vegetation and is in good condition. WS is still vegetated. LS pipe end under water and blocked off by plywood so unable to measure culvert size. 4/24/2012 Limited inspection on WS and LS slopes due to dense vegetation. Need photos of cleared WS and LS slopes. This crossing was listed in the USACE Periodic Inspection report as Corp's inspect ID# USACE_CESPK_M13E_2011_p_0134 for unknown culvert size on LS and no outlet visible on WS.

Overview of crossing looking D/S at left bank of Cherokee Canal.

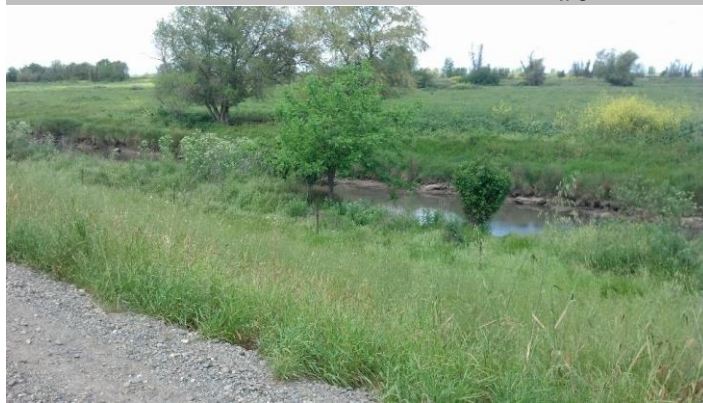
Photo 2 of 3 : UCIP_FA_2018_52161_67386.jpg

View of WS slope and berm.

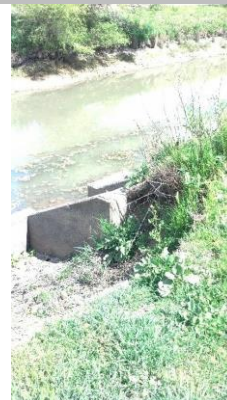
Photo 1 of 3 : UCIP_FA_2018_52164_67401.jpg

Comment Code						
Inspector Comment						
FS_ID:52164 DS_ID:16375 EP_NO: N/A Repair Type: Non-Urgent Crossing Status: Found UCIP Comments: 5/30/2017 Erosion still present at WS headwall. Pipe has been selected to be internally cleaned and inspected as part of the DMP project. (DWR Sutter Yard- A/Freitag)11/17/2016 Erosion still present at WS headwall. (DWR Sutter Yard- A/Freitag)4/26/2016 Erosion still present behind the WS headwall. The rest of the crossing appears in good condition.6/30/2015 Erosion still present behind the WS headwall. Everything thing else with the crossing appeared to be in good condition.12/4/2013 Same as last inspection.5/28/2014 Same as last inspection.7/08/2013 Erosion problem same as last inspection. WS and LS slopes have been cleared of vegetation and are in good shape.4/24/2012 Erosion present behind WS headwall. Limited inspection on WS and LS slopes due to dense vegetation. Need photos of cleared WS and LS slopes during next inspection. FIELD_STRUCT_DESC: 30-inch corrugated metal drainage pipe through the levee, 13.1 feet below the crown. Flap gate on the waterside (WS) end. Concrete "U" headwalls on both WS and landside (LS). [Additional Reference(s): DWR Levee Log, 1993. USACE Sacramento O&M Manual 519, June 1962 (HLM 20.15)] FS Date: 6/8/2017 10:23:50 AM

Erosion behind WS headwall looking at the downstream edge of headwall.

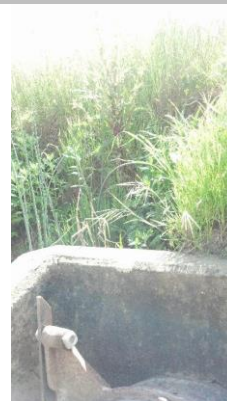
Photo 2 of 3 : UCIP_FA_2018_52164_67400.jpg

Erosion behind WS headwall at the upstream edge of headwall.

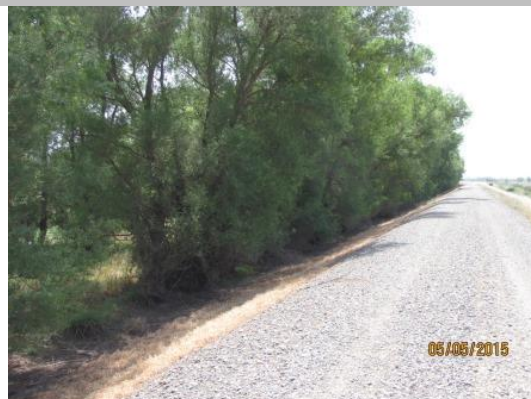
Photo 1 of 1 : FA_2018_MA0013_301_6_20180905_00002.jpg

LM Start	20.43	Rating **	M	Issue No.	6
LM End	20.74	Issue Type +	Ma	Location *	LS
Category	Earthen Levee			GPS Latitude/Longitude	
				Start	End
Item	Trim / Thin Trees			39.373091 °	39.370795 °
				-121.845225 °	-121.850124 °
DWR ID	DWR_MA0013_02_s_2013_6				
Comment Code					
T1 : Trim trees to at least five feet above ground level.					
Inspector Comment

View of the overgrown trees along the landside slope.

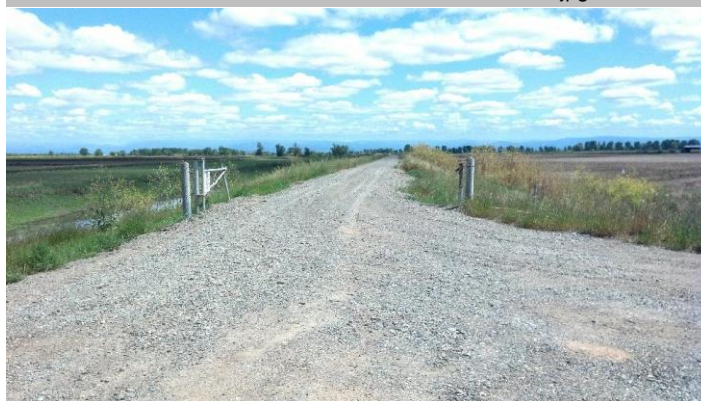
Photo 1 of 3 : UCIP_FA_2018_52170_67462.jpg

FS_ID:52170
DS_ID:16394
EP_NO: N/A
Repair Type: Non-Urgent
Crossing Status: Found
UCIP Comments: 5/30/2017 WS flap gate showing signs of rusting and deterioration but still appears to be able to function properly. Pipe has been selected to be internally cleaned and inspected as part of the DMP project. (DWR Sutter Yard - A Freitag)11/17/2016 WS flap gate is really rusted and deteriorated but it appears to still function properly. (DWR Sutter Yard - A Freitag)4/26/2016 WS flap gate is really rusted and deteriorated. May need to be replaced. The rest of the crossing appeared in good condition.6/30/2015 Crossing is in good condition. No noticeable issues to be reported.5/28/2014 Same as last inspection.12/4/2013 WS and LS slopes are in good condition.7/08/2013 Same as last inspection.4/24/2012 Limited inspection on WS and LS slopes due to dense vegetation. Need photos of cleared WS and LS slopes. This crossing was listed in the USACE Periodic Inspection report as Corp's inspect ID# USACE_CESPK_M13E_2011_p_0251 for no outlet visible on WS. FIELD_STRUCT_DESC: 24-inch corrugated metal drainage pipe through the levee, 11.6 feet below the crown. Flap gate on the waterside (WS) end. Concrete "U" headwalls on both WS and landside (LS). Rusted gate located on the WS (gate stuck). [Additional Reference(s): DWR Levee Log, 1993. USACE Sacramento O&M Manual 519, June 1962 (HLM 22.08)]

Overview of crossing looking upstream at the left bank of Cherokee Canal.

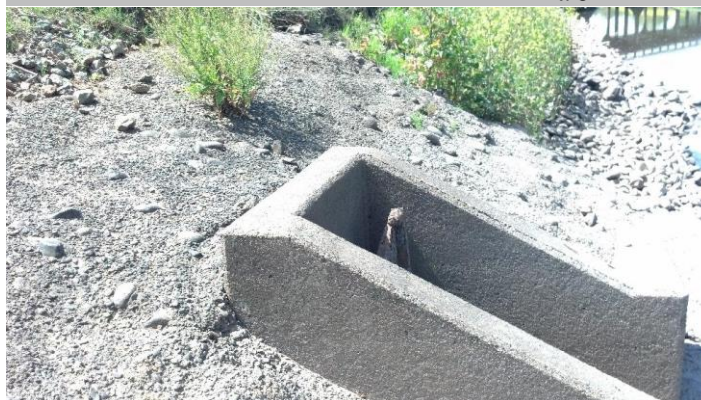
Photo 2 of 3 : UCIP_FA_2018_52170_67460.jpg

View of WS headwall.
